Quarterly Status Report #5

Lamb Island Dairy Remediation

SFWMD Contract No. C-13410

HSA Engineers & Scientists

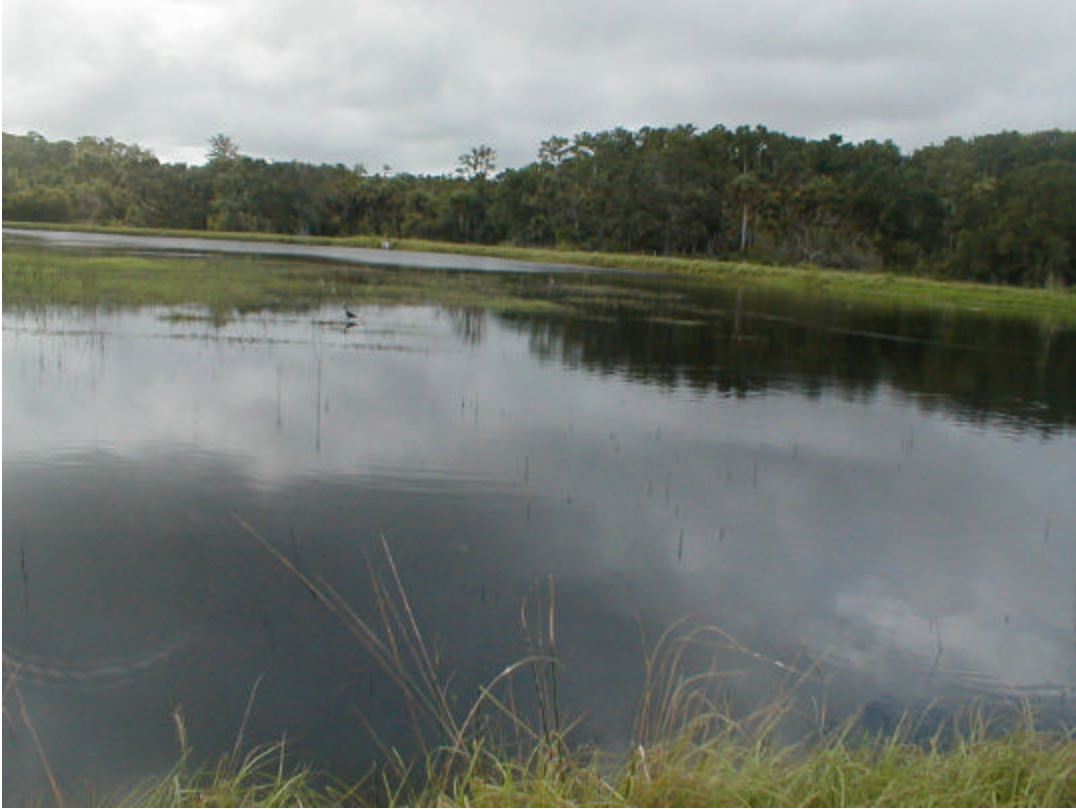
On June 8, 2005 sampling was completed on site due to rainfall greater than 0.5 inches within the basin in the last 48 hours. A significant amount of rain had fallen and the all ditches and wetland areas had water in them. **Figure 2** shows a view of the created wetland area on the south side of the property. **Figure 3** is a view of the HIA area ditch and berm looking east. Flow off site was observed at the SW-5 sampling location only. Only sampling location SW-4 was not sampled because it was inaccessible. GW-1 and SW-6 were not sampled because they are only monitored on a quarterly basis. **Table 1** shows sampling results for all locations.

Figure 2. View of created wetland area on south side of site looking towards SW-5

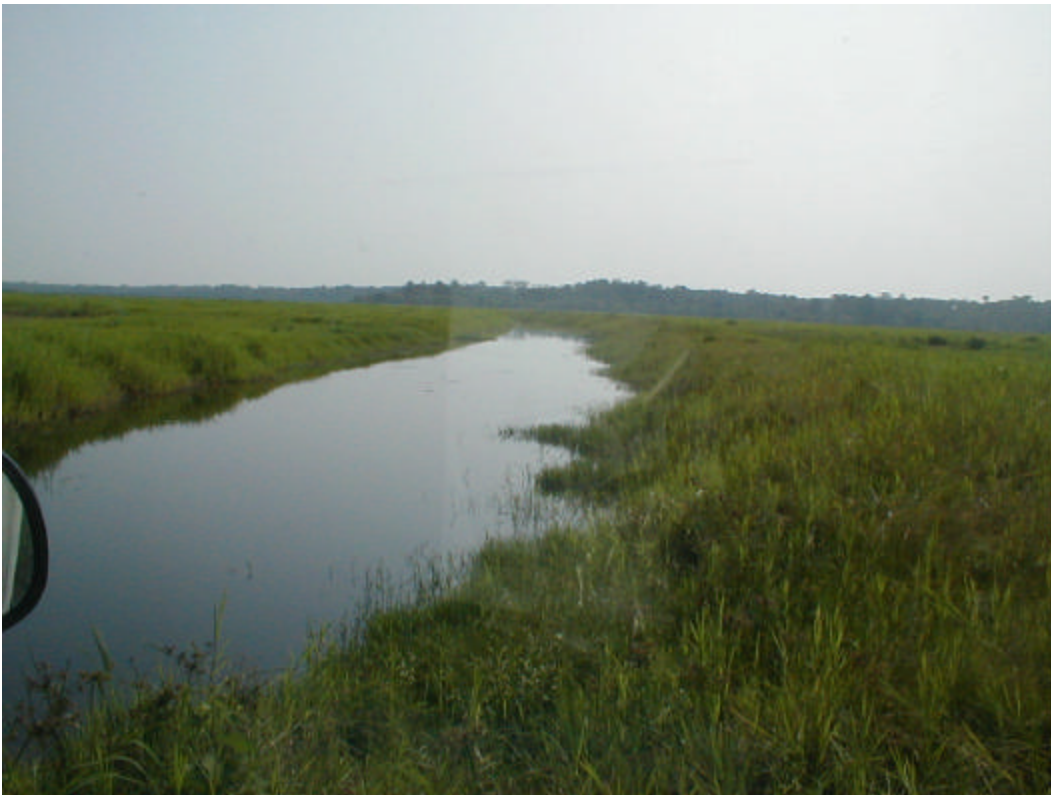
Figure 3. View looking East of HIA ditch and berm.
